# SEM INVESTIGATION OF SILICON DIODES USING THE ELECTRON BEAM INDUCED CURRENT METHOD

1Lt Mark E. Snyder

December 1984

## Final Report

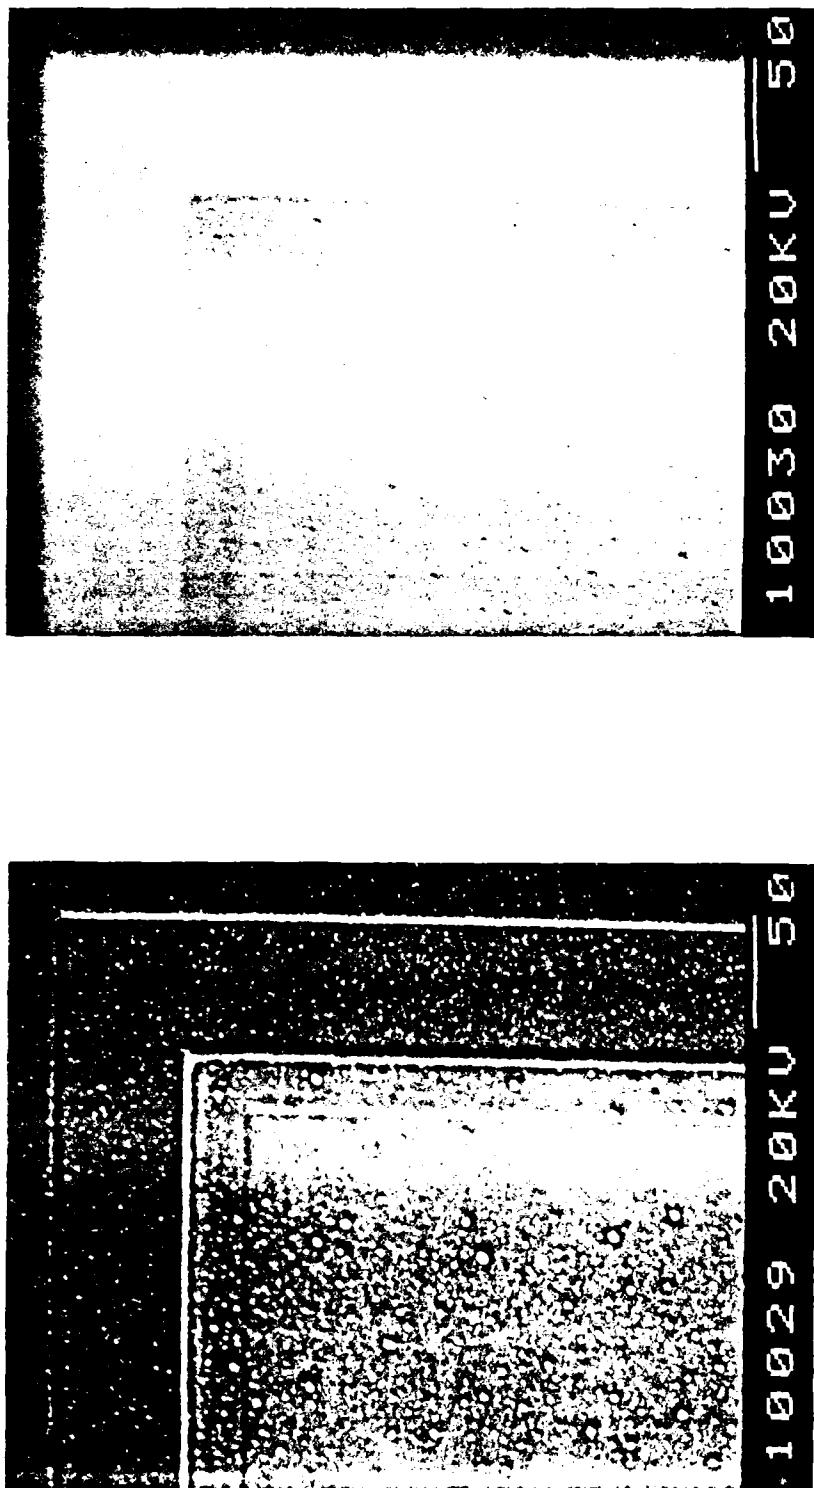
Figure 34. (a) Secondary image of diode 081 at 400x. (b) The EBIC image of diode 081 at 400x.

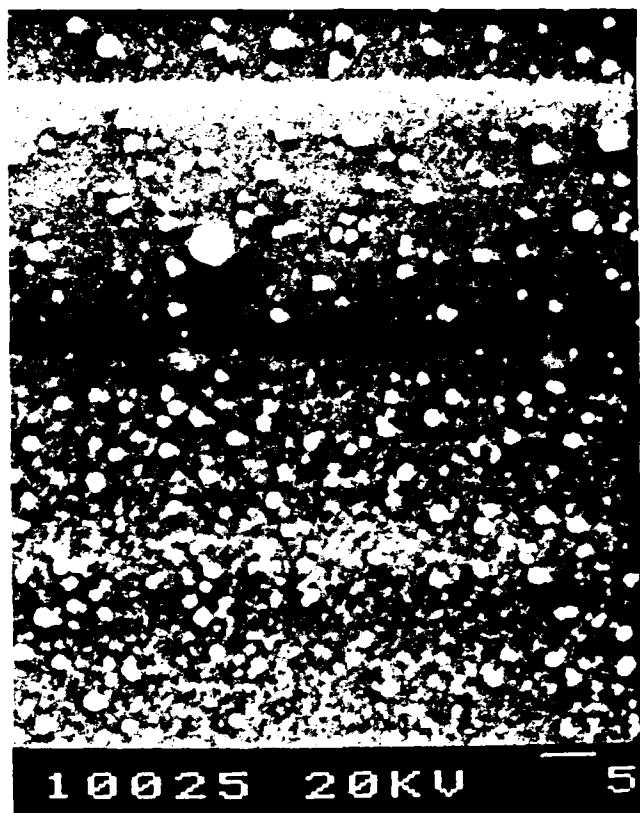
Figure 35. Secondary image of metallization pits on diode 086 at 2000x.

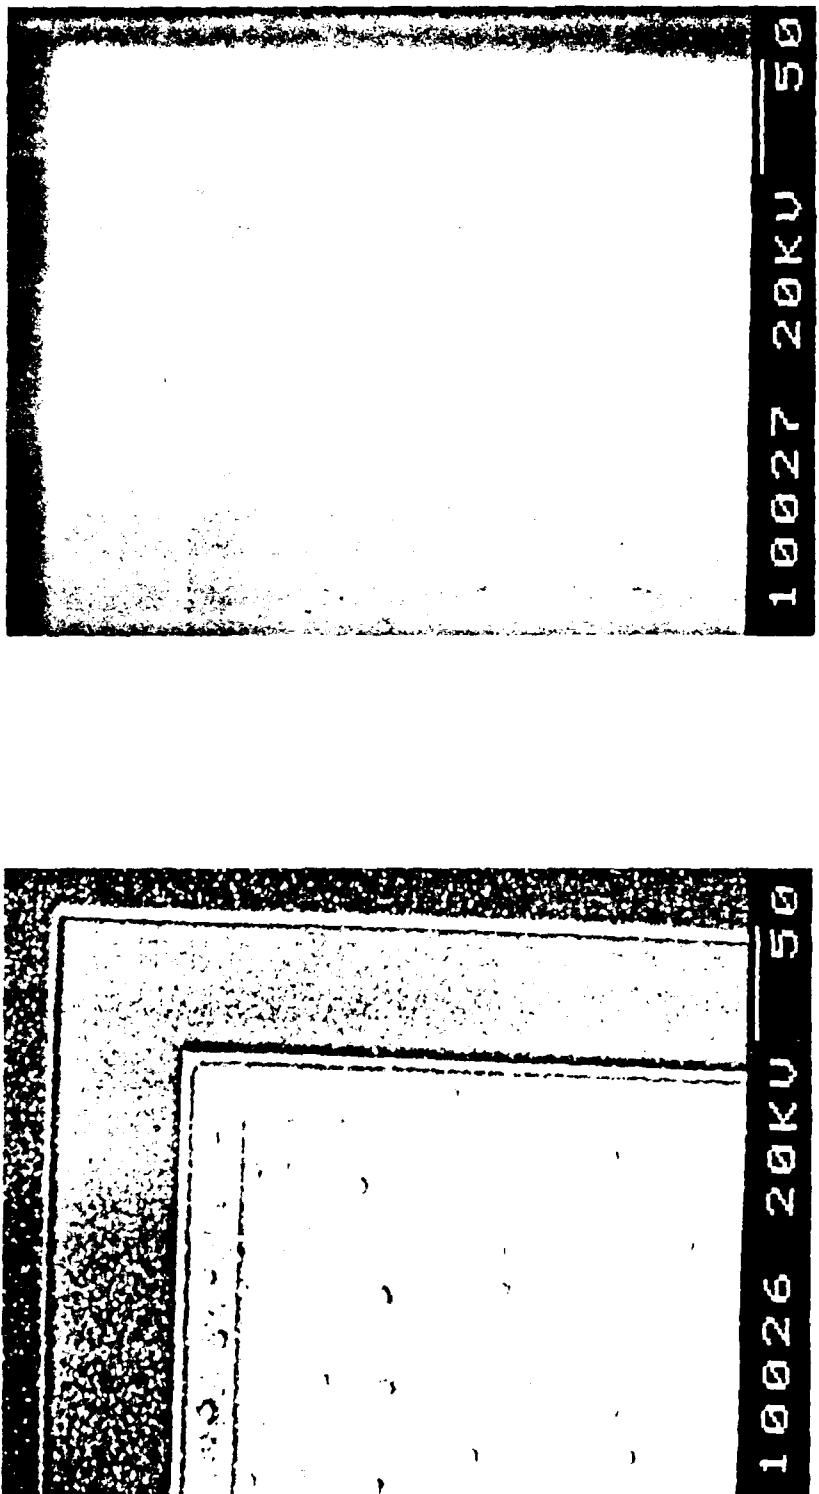
Figure 36. (a) Secondary image of diode 086 at 400x. (b) The EBIC image of diode 086 at 400x.

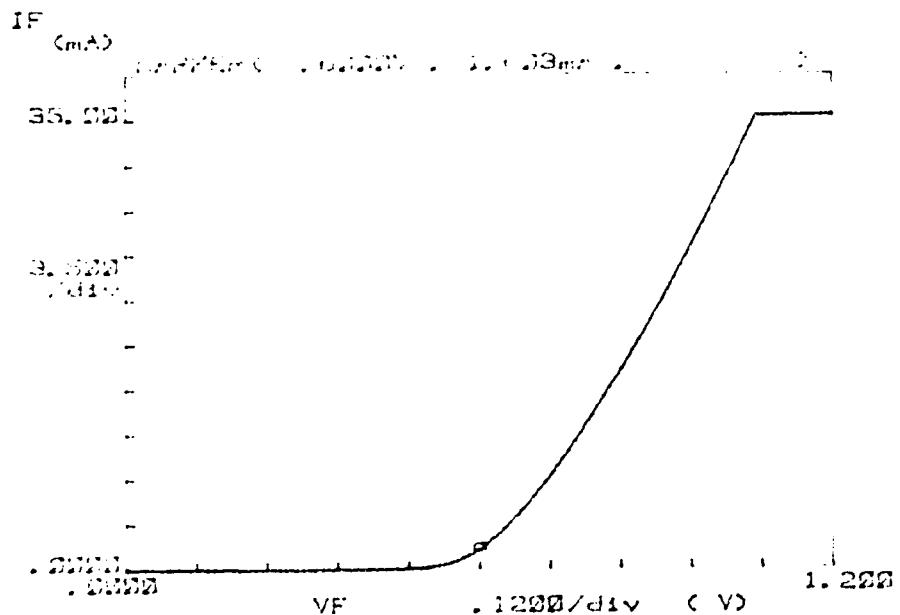
Figure B8. Posttest I-V characteristics for diode 100 in the forward region. The reverse region registers no recordable current flow under any bias of between -17 V and -80 V.
